Miscellaneous Paper SL-96-1  
February 1996

## Forced Entry Testing of Five-Minute Walls

Prepared for U.S. Department of State,  
Office of Foreign Building Operations

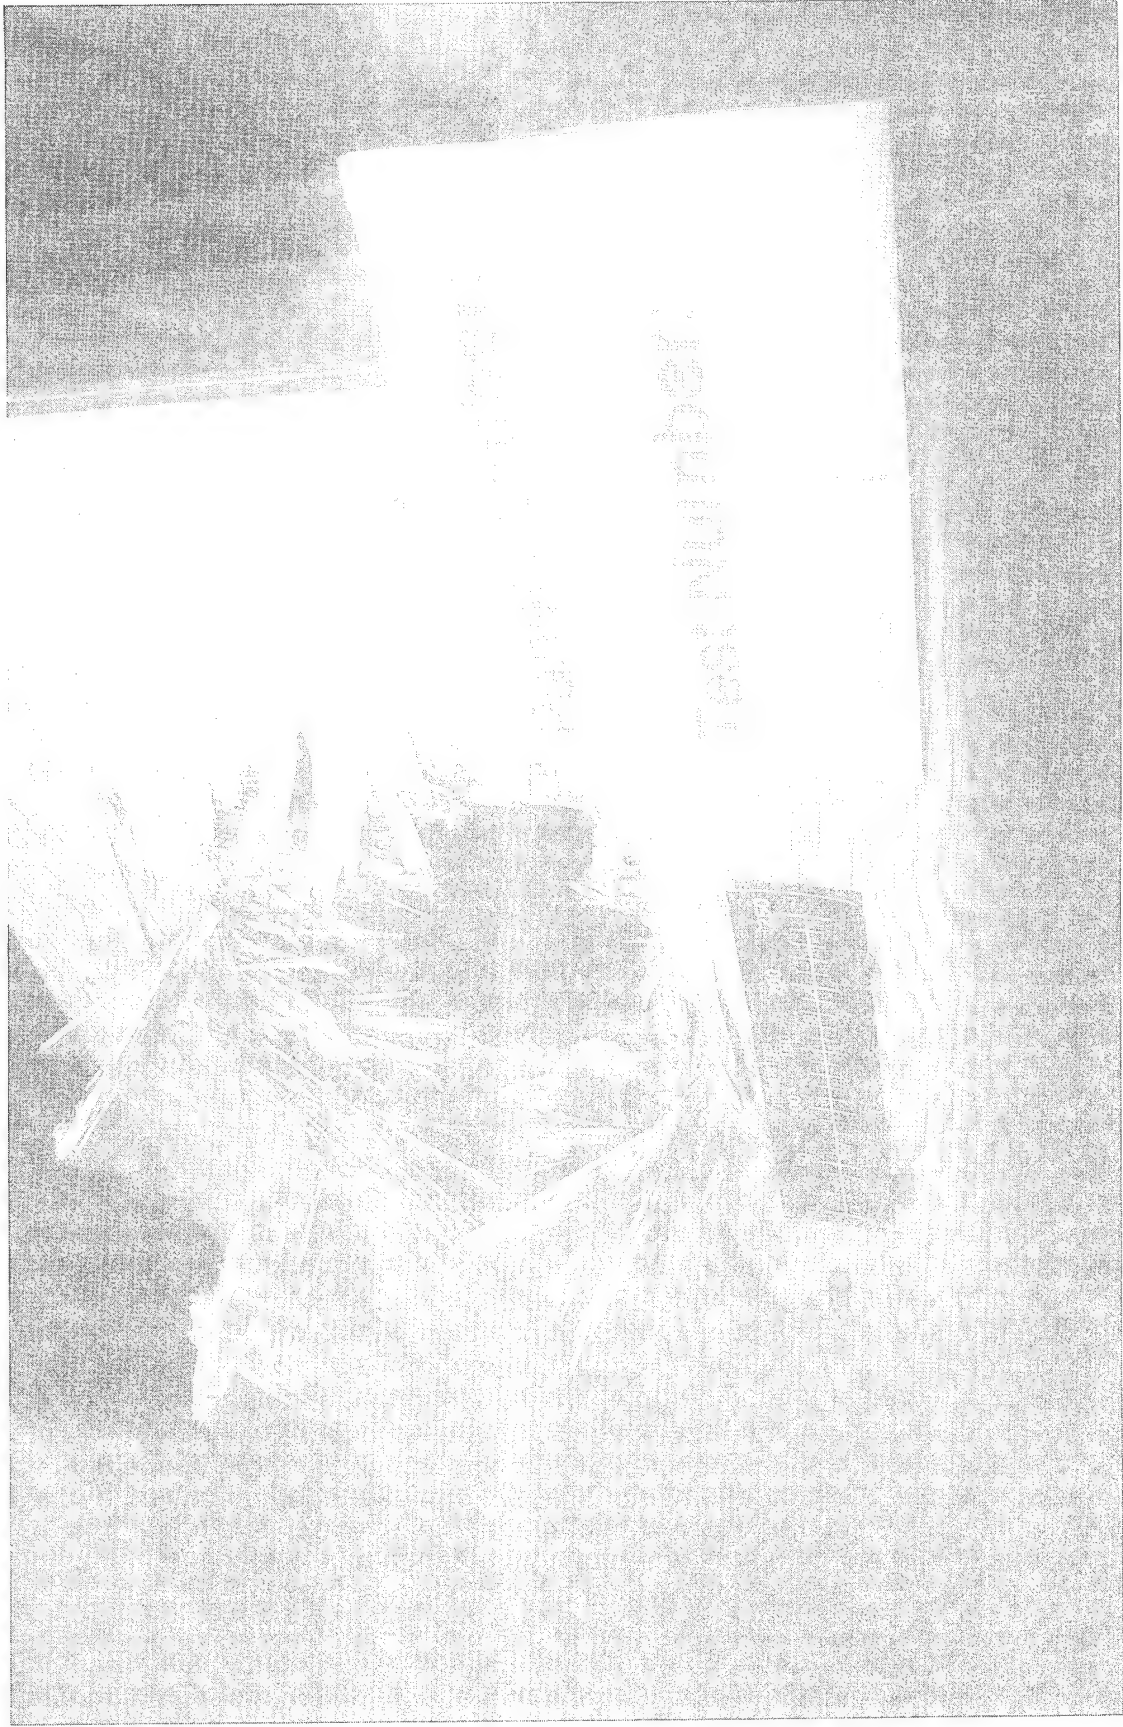
Figure 43. Protect side of panel XPK-05N-DOS-02 after the initial assault phase of test 2-4

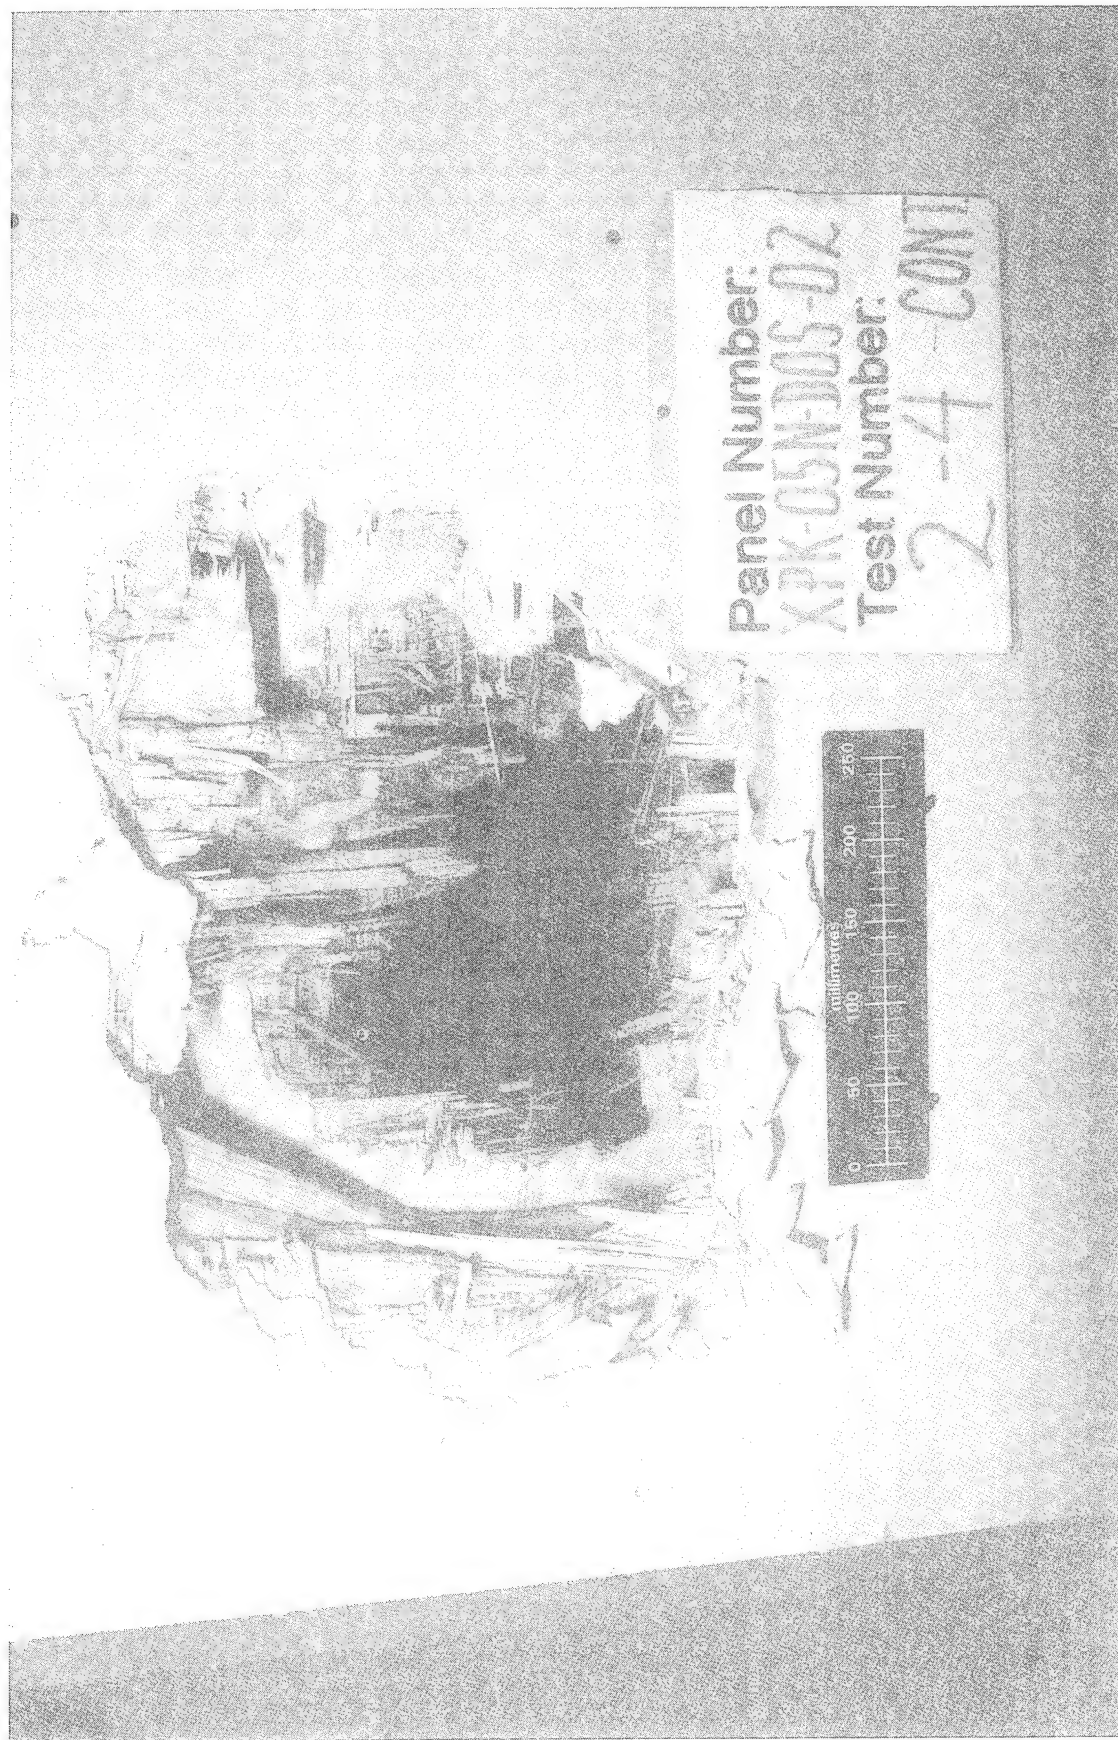
Figure 44. Assault side of panel XPK-05N-DOS-02 after the second assault phase of test 2-4

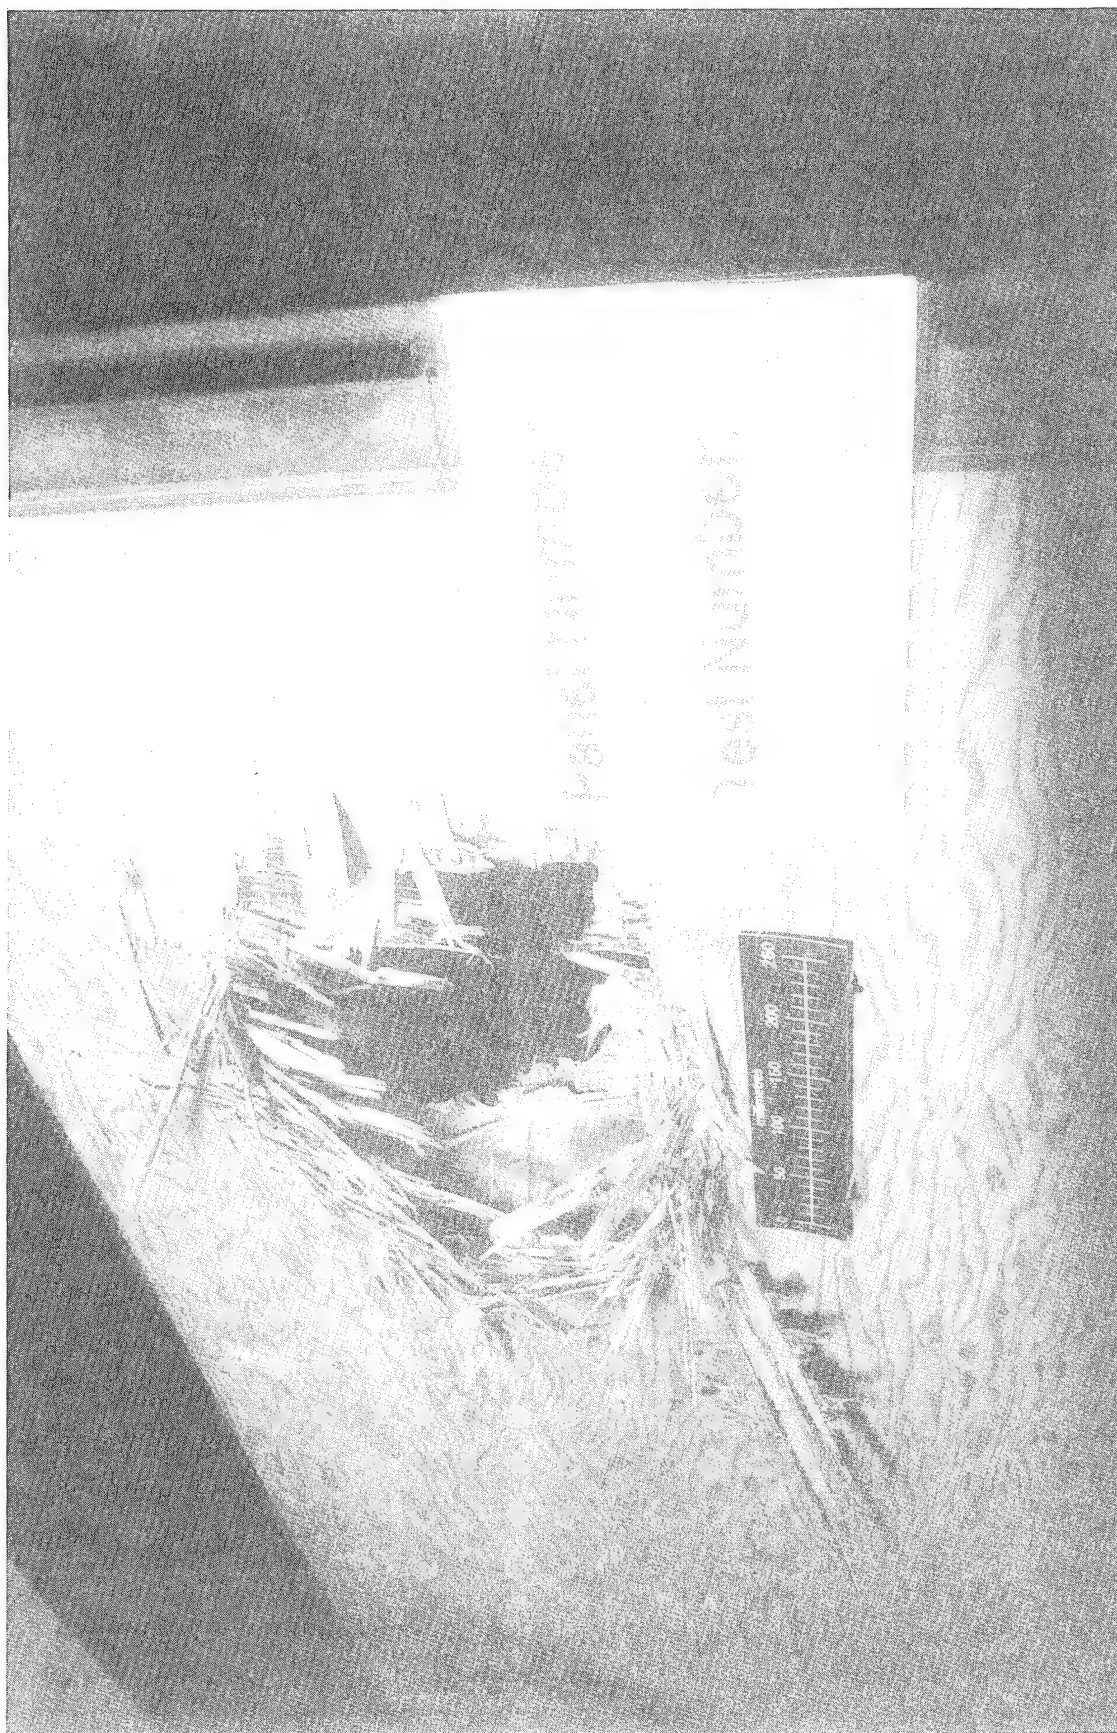
Figure 45. Protect side of panel XPK-05N-DOS-02 after the second assault phase of test 2-4

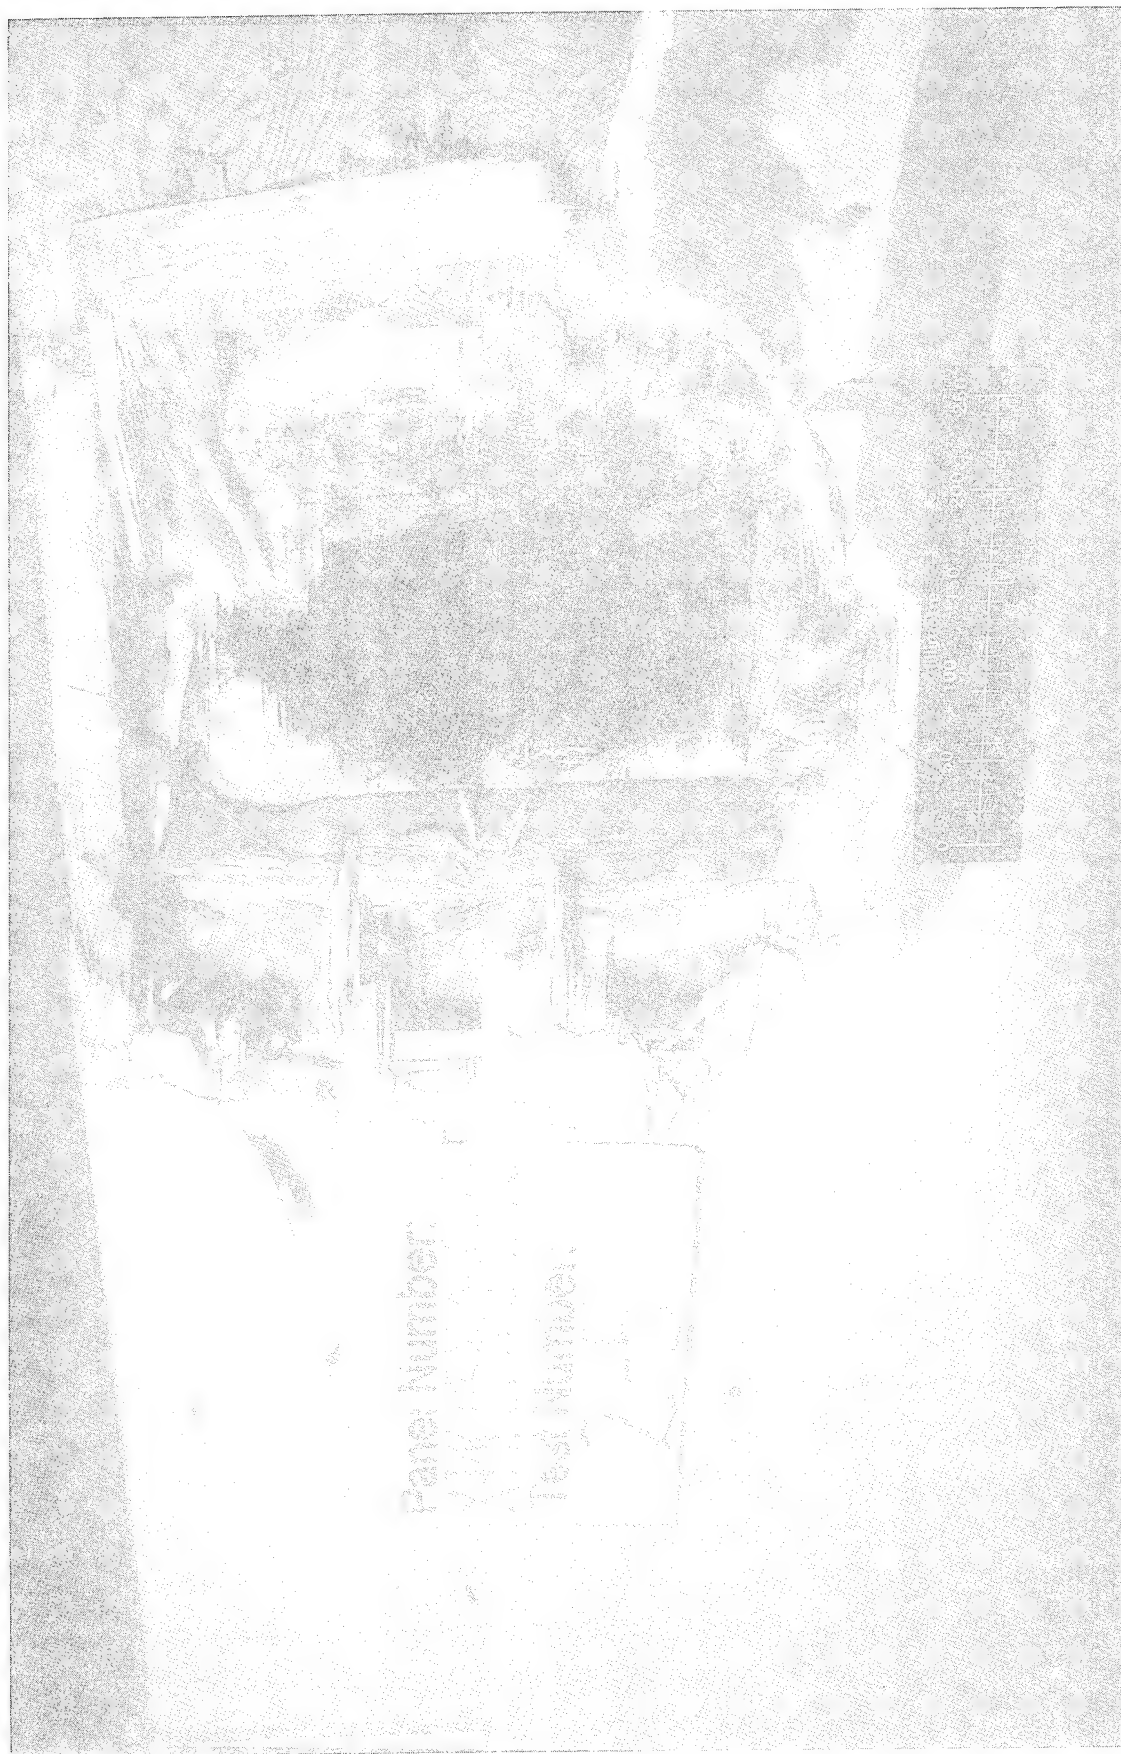
Figure 46. Assault side of panel XPK-05N-DOS-02 after the initial assault phase of test 2-5

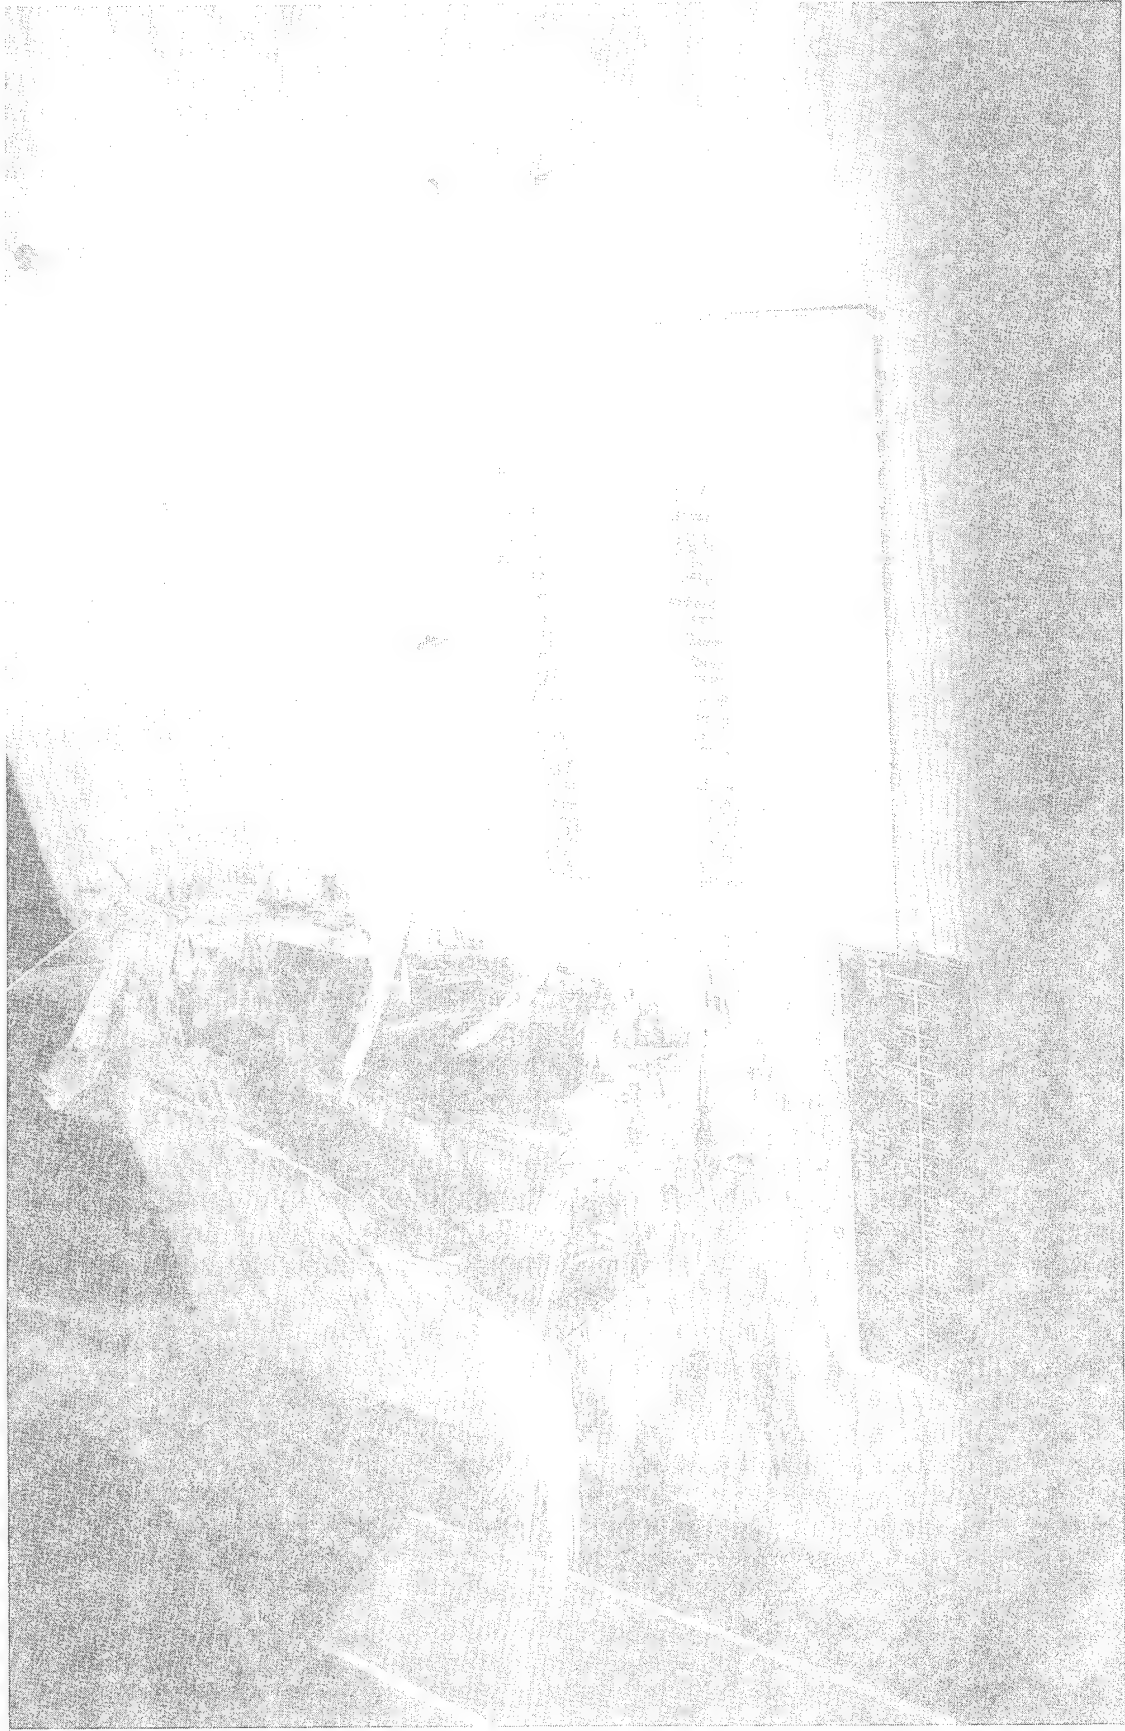
Figure 47. Protect side of panel XPK-05N-DOS-02 after the initial assault phase of test 2-5

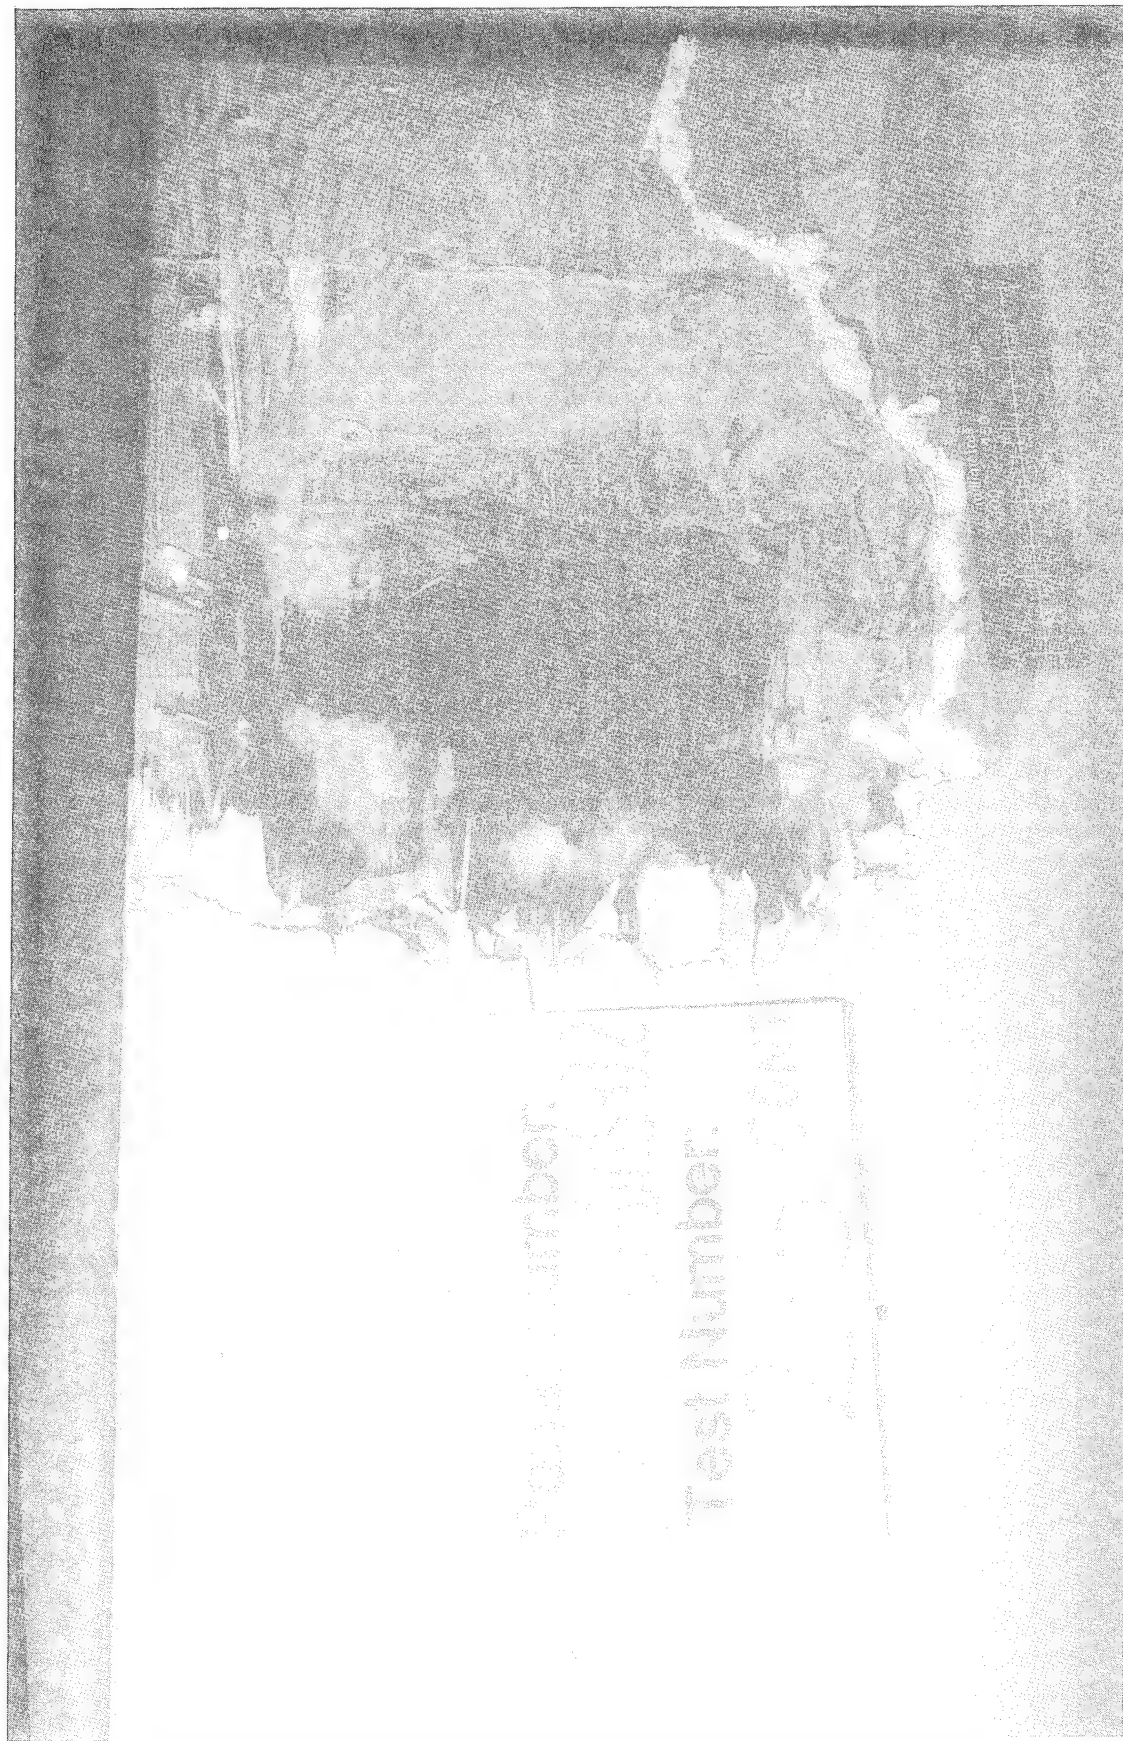
Figure 48. Assault side of panel XPK-05N-DOS-02 after the second assault phase of test 2-5

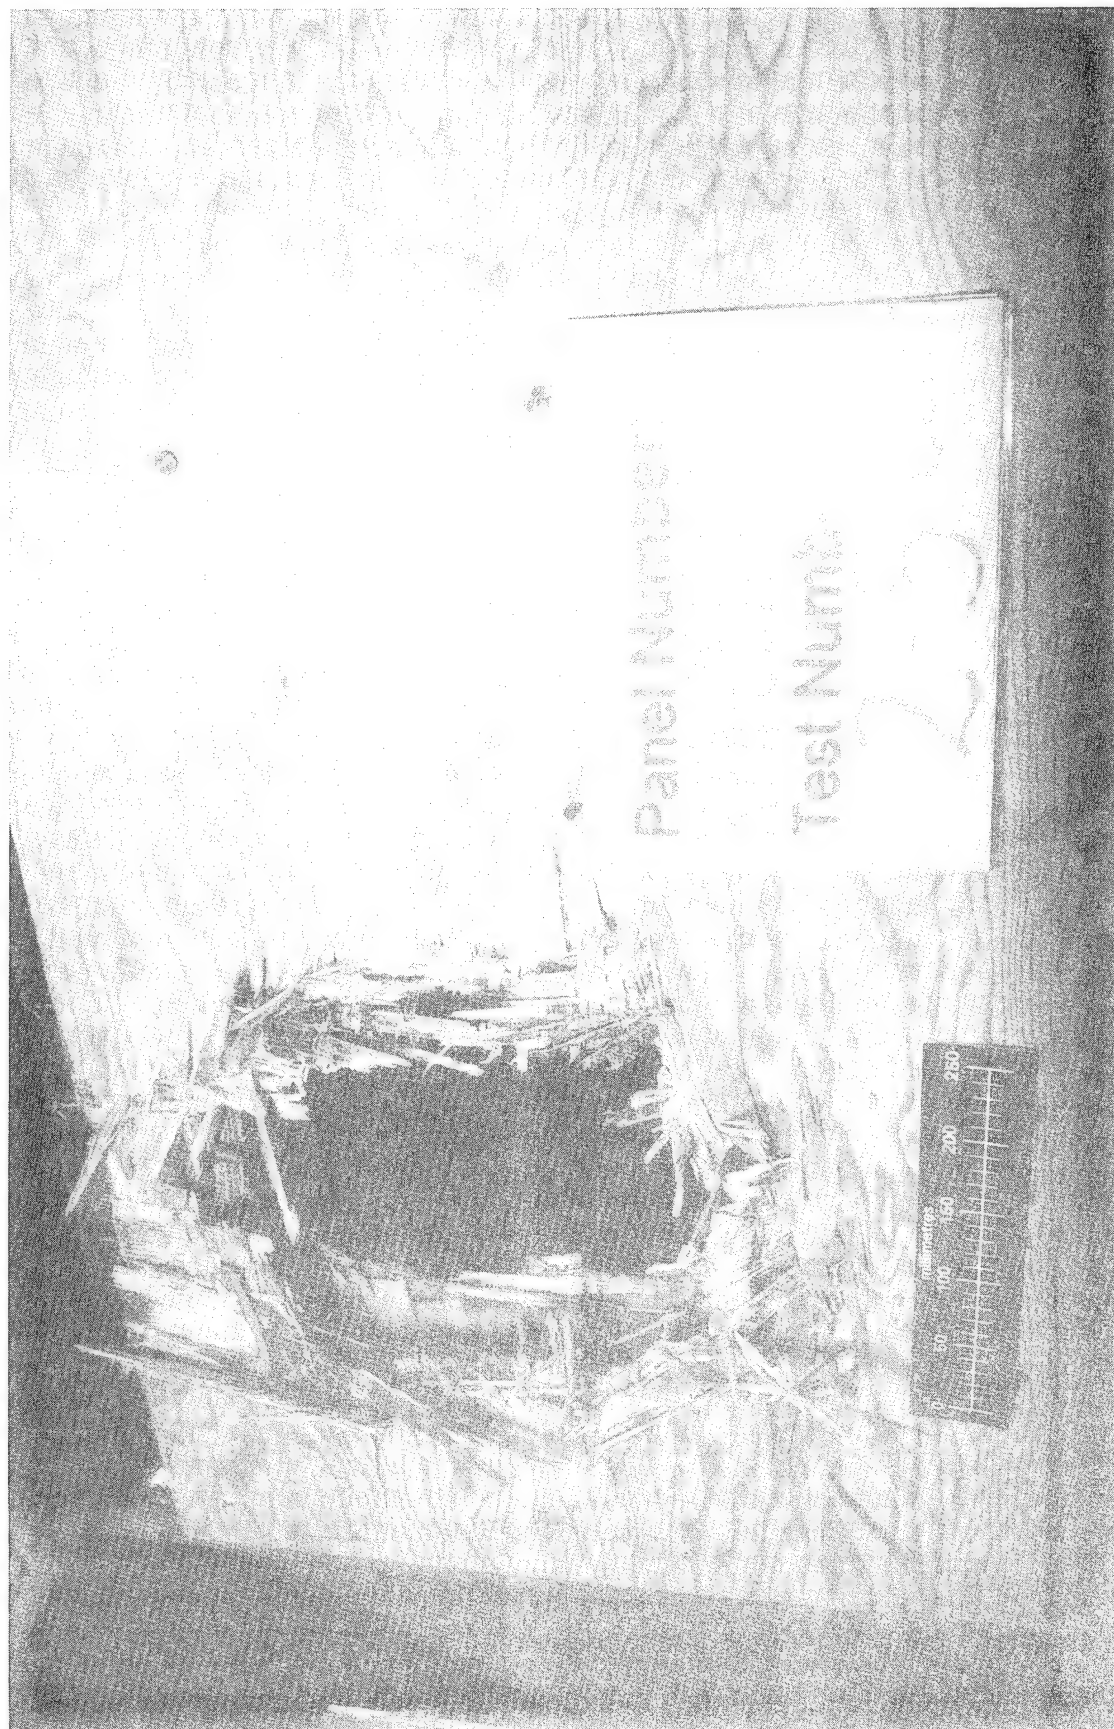
Figure 49. Protect side of panel XPK-05N-DOS-02 after the second assault phase of test 2-5

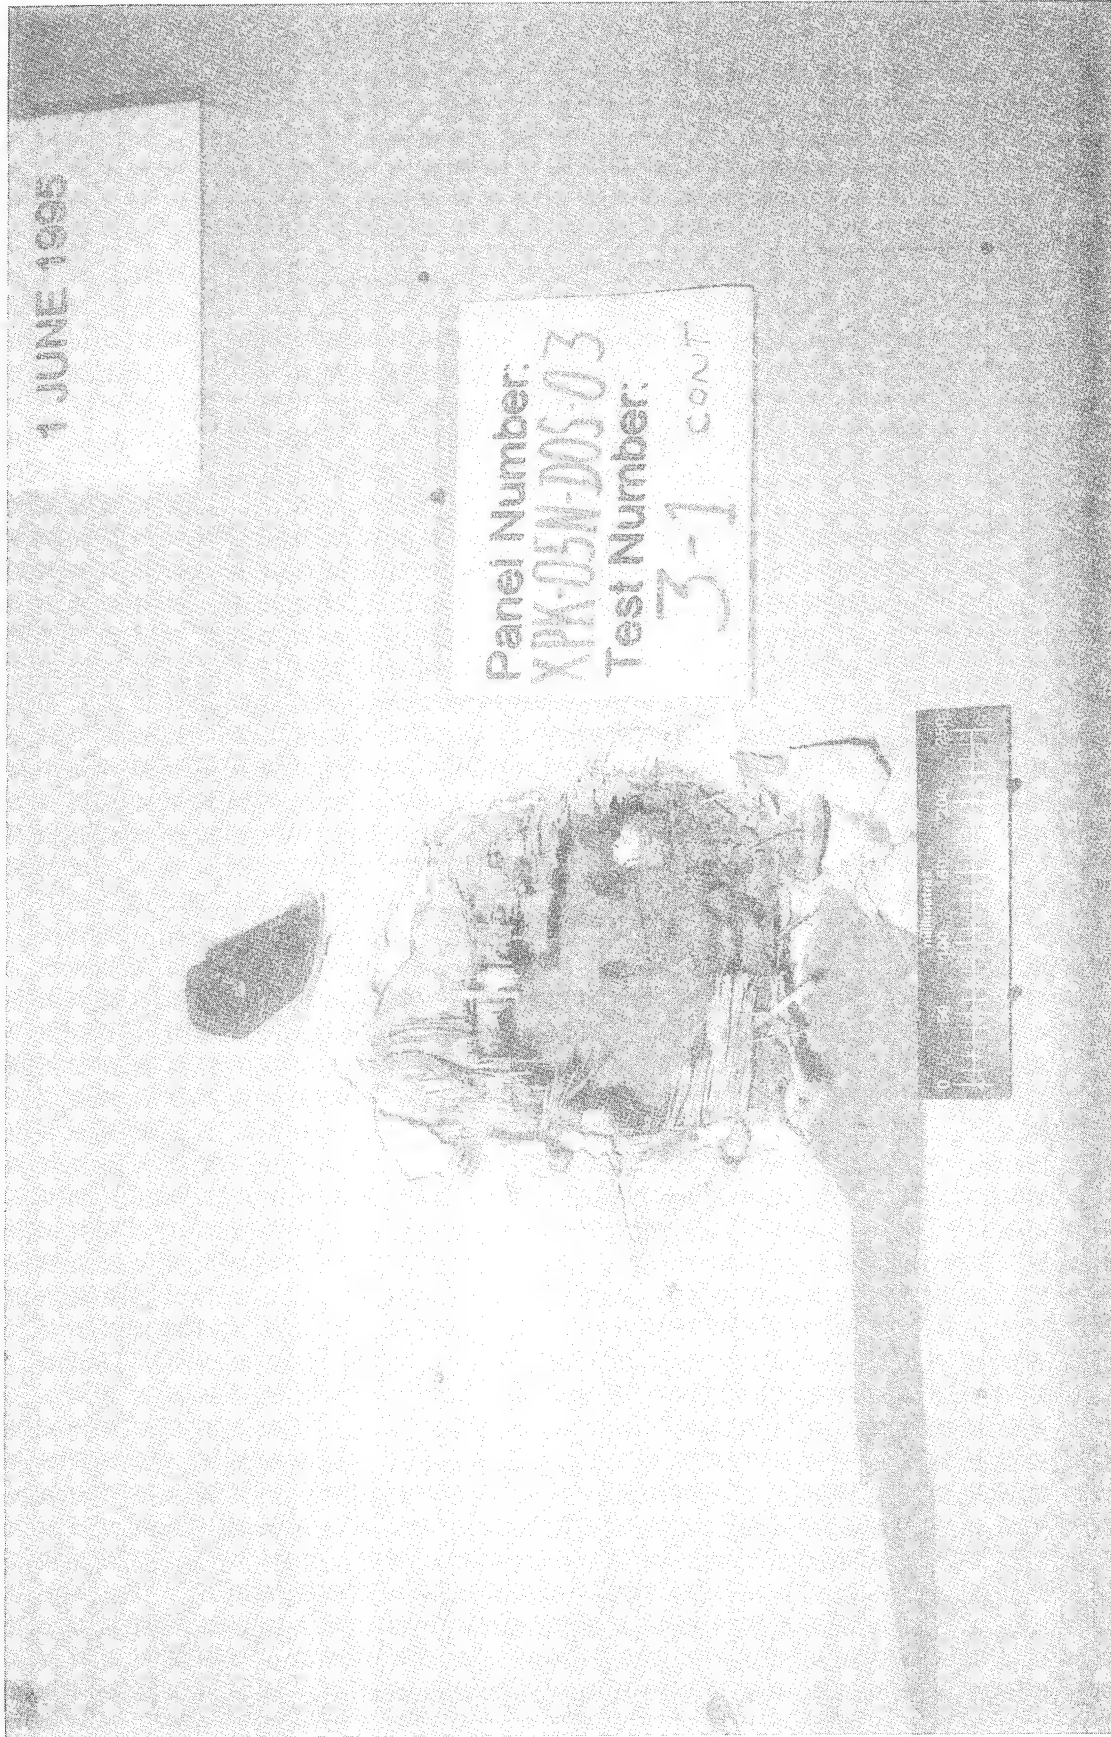
Figure 52. Assault side of panel XPK-05N-DOS-03 after the second assault phase of test 3-1

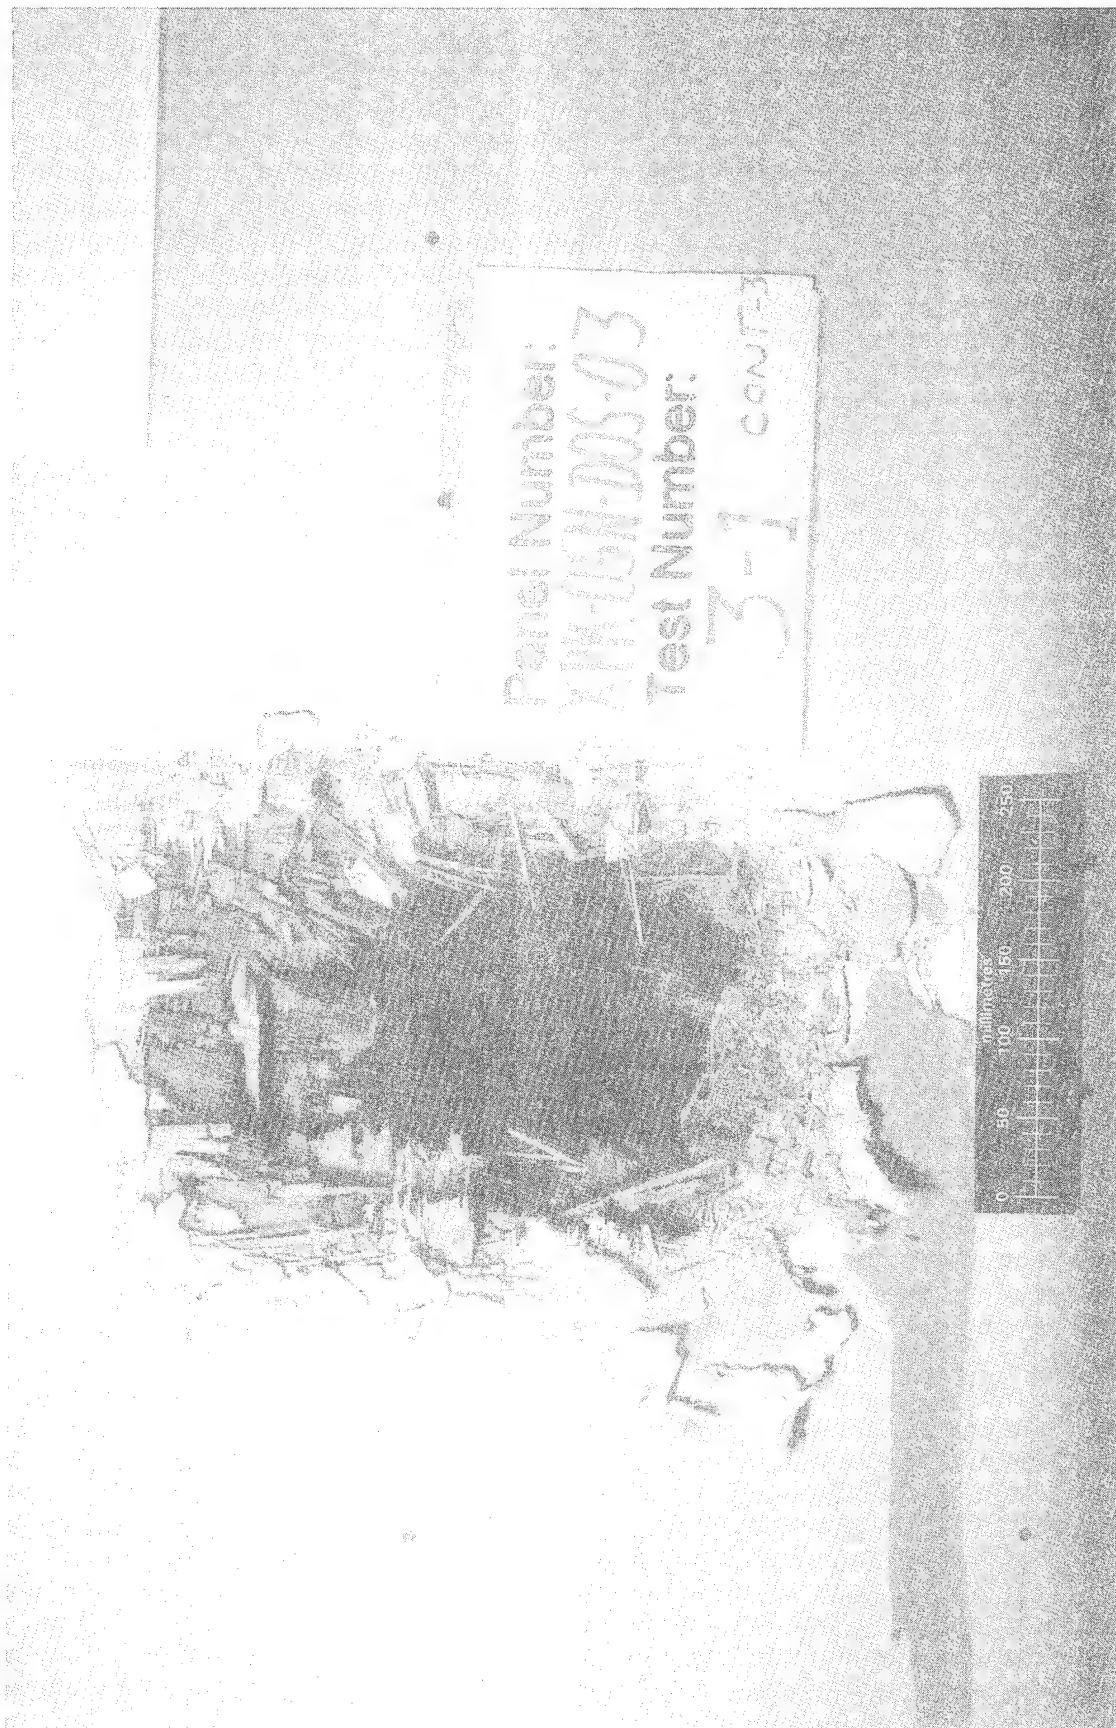
Figure 53. Assault side of panel XPK-05N-DOS-03 after the third assault phase of test 3-1

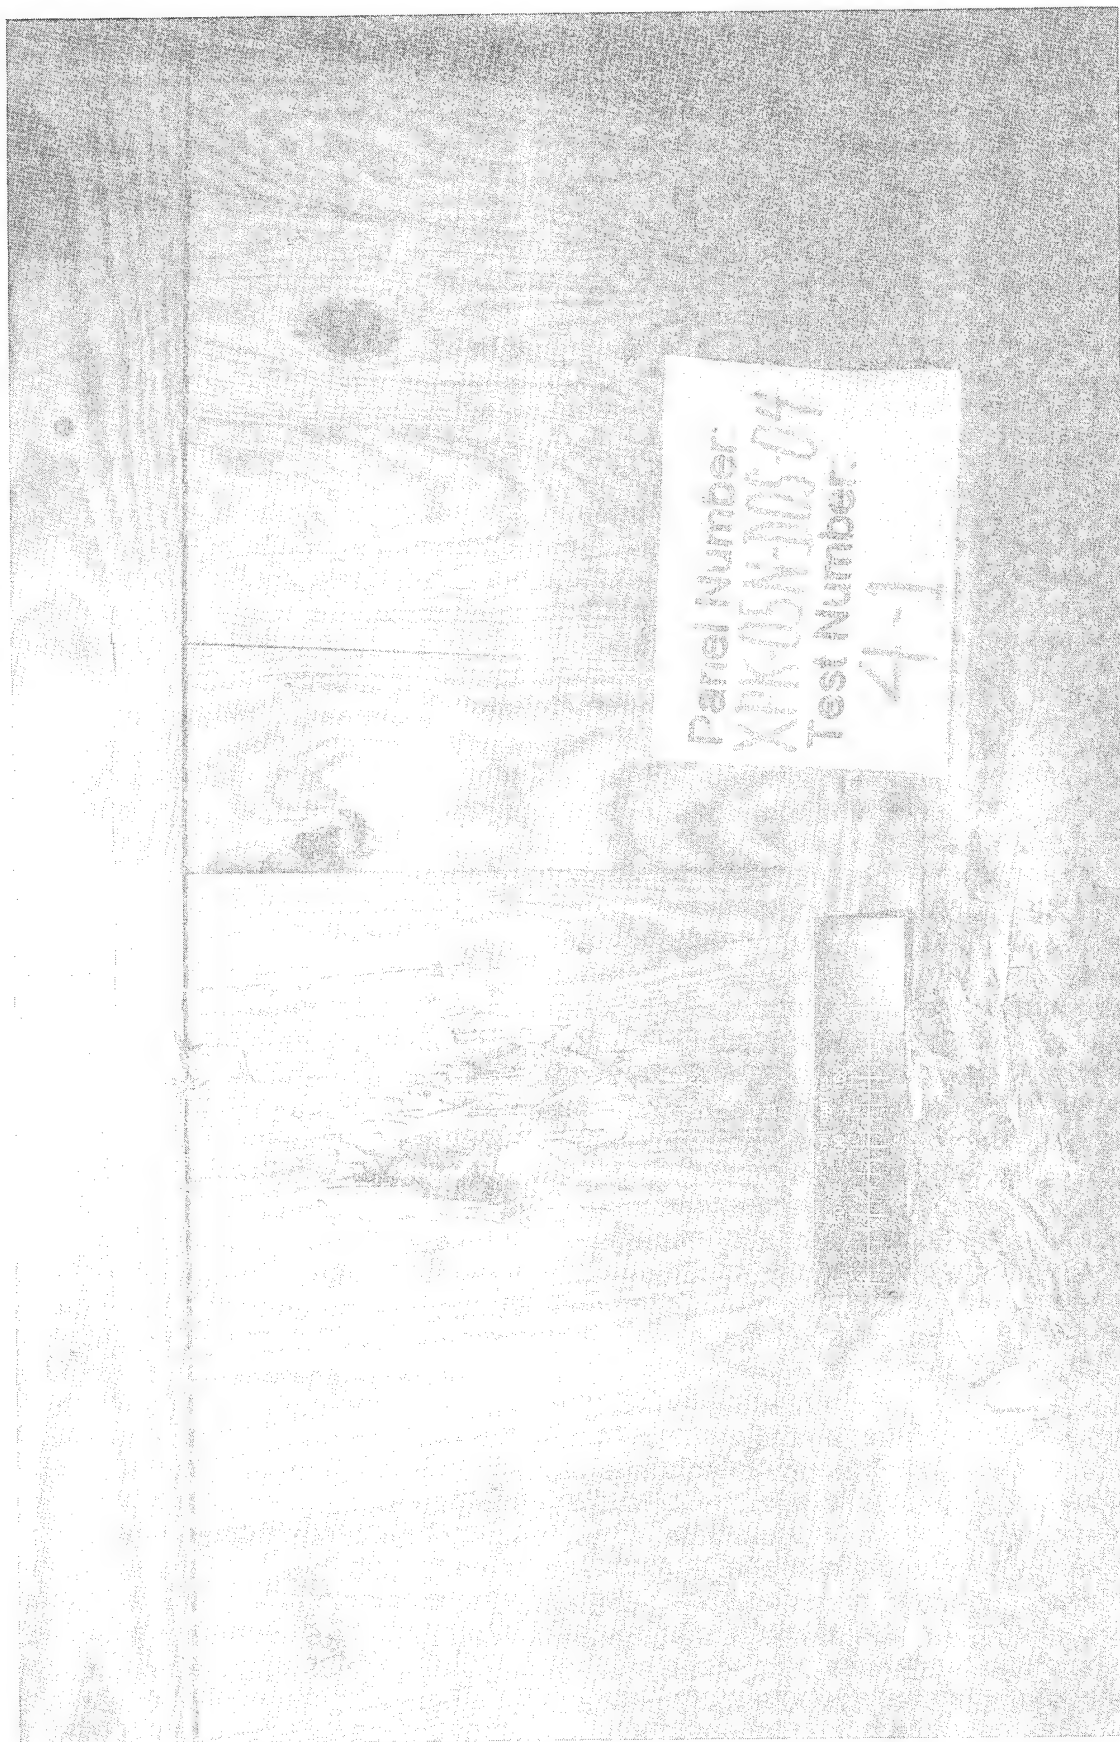
Figure 55. Assault side of panel XPK-05N-DOS-04 after test 4-1

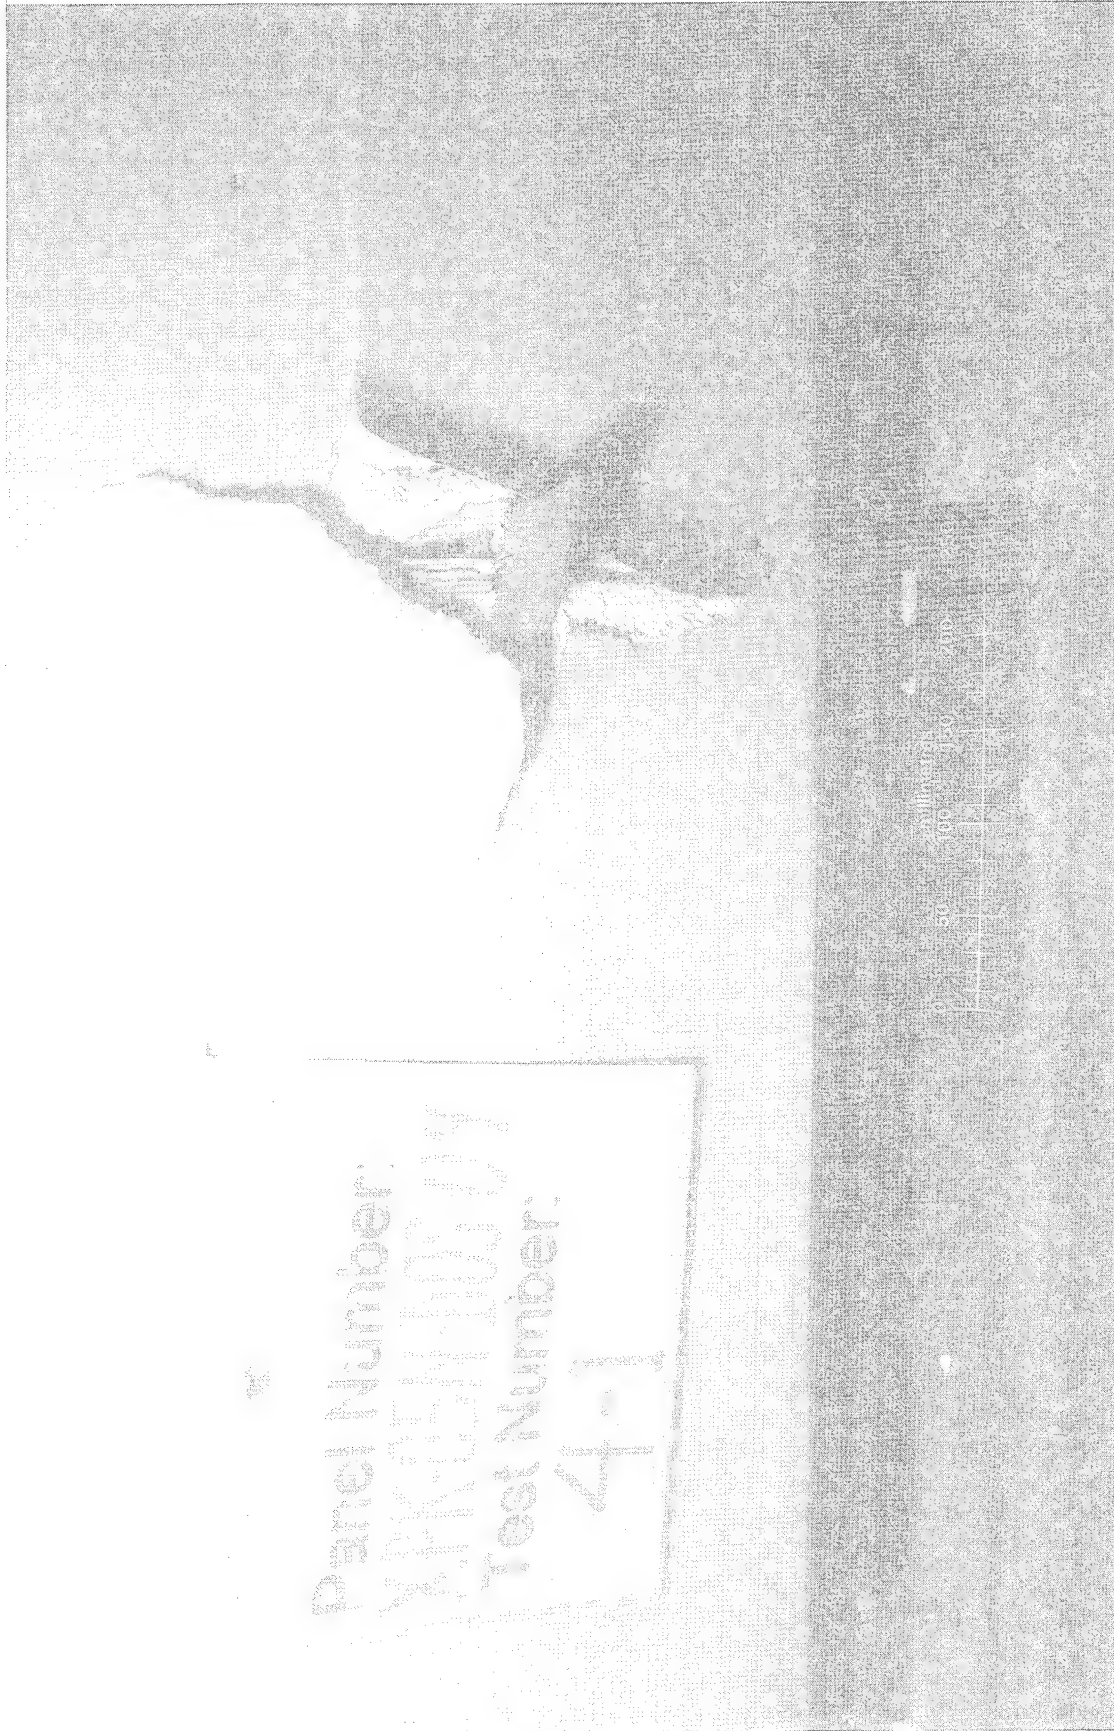
Figure 56. Protect side of panel XPK-05N-DOS-04 after test 4-1
